DEPARTMENT OF TRANSPORTATION**DIVISION OF ENGINEERING SERVICES**

Quality Assurance and Source Inspection

Contract #: 04-0120F4Cty: SF/ALA Rte: 80 PM: 13.2/13.9File #: 1.28**WELDING INSPECTION REPORT****Resident Engineer:** Siegenthaler, Peter**Address:** 333 Burma Road**City:** Oakland, CA 94607**Report No:** WIR-017102**Date Inspected:** 29-Sep-2010**Project Name:** SAS Superstructure**OSM Arrival Time:** 1000**Prime Contractor:** American Bridge/Fluor Enterprises, a JV**OSM Departure Time:** 1830**Contractor:** American Bridge/Fluor Enterprises, a JV**Location:** Job Site

| Bridge No: | 34-0006 | | | Component: | Orthotropic Box Girder | | |

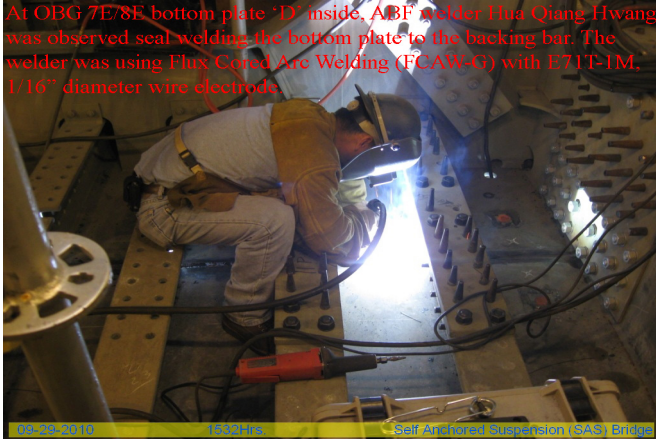
Still at the same plate mentioned above, QA randomly observed ABF/JV qualified welders Xiao Jian Wan and Hua Qiang Huang seal welding bottom plates 'D' to the backing bar. The welders were utilizing a dual shield Flux Cored Arc Welding (FCAW-G) with E71T-1M, 1/16" diameter wire electrode and implementing Caltrans approved Welding Procedure Specification (WPS) ABF-WPS-D15-3040A-1. The joint had a single V-groove butt joint design with the bottom plate and backing bar being seal welded. The plate with the backing bar was preheated to greater than 150 degrees Fahrenheit using propane gas torch prior welding. During the shift, ABF QC William Sherwood was noted monitoring the welder. The welders have completed seal welding on both sides of the plates and then hand welded using the same process the two ends (north side, 500mm and south side, 1000mm) of the splice wherein the SAW track mounted feeder has a limited access. These two ends were not completely welded but filled 50% at the end of the shift.

At OBG 7E/8F bottom plate "D" inside, ABF welder Hua Qiang Hwang was observed seal welding the bottom plate to the backing bar. The welder was using Flux Cored Arc Welding (FCAW-G) with E71T-1M, 1/16" diameter wire electrode.

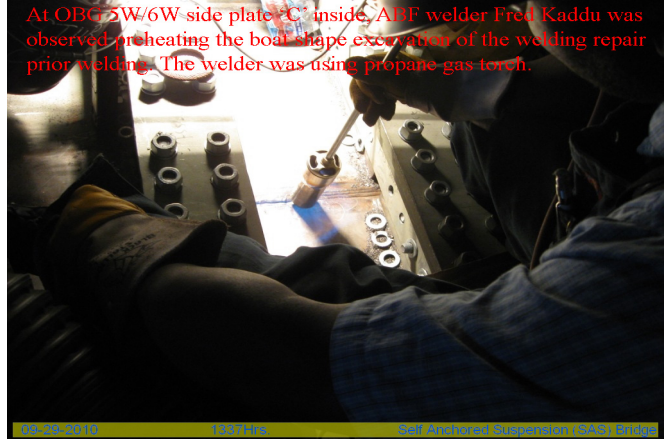
At OBG 5W/6W side plate 'C' inside, QA randomly observed ABF/JV qualified welder Fred Kaddu ID # 2188 perform CJP groove welding repair. The welder was observed welding in the 3G (vertical) position utilizing Shielded Metal Arc Welding (SMAW) with 1/8" diameter E7018H4R electrode implementing welding procedure ABF-WPS-D15-1000-Repairs. The repair excavations were preheated to more than 140 degree Fahrenheit using propane gas torch prior welding. During the shift, ABF QC Jim Cunningham was noted monitoring the welder. Prior welding, ABF QC Jim Cunningham was also observed performing Magnetic Particle Testing (MT) using Parker Contour Probe with red magnetic powder as detecting media on the repair excavation. There were no significant defects noted during the test. At the end of the shift, all five UT repairs on this plate have been completed.

At OBG 5W/6W side plate "C" inside, ABF welder Fred Kaddu was observed preheating the boat shape exterior of the welding repair prior welding. The welder was using propane gas torch.
